Installation and Initial Performance of 60" ADS N-12HC[®] HDPE Pipes

RI 01-037

June, 2002

**INSTALLATION AND INITIAL PERFORMANCE
OF 60" ADS N-12HC[®] HDPE PIPES**

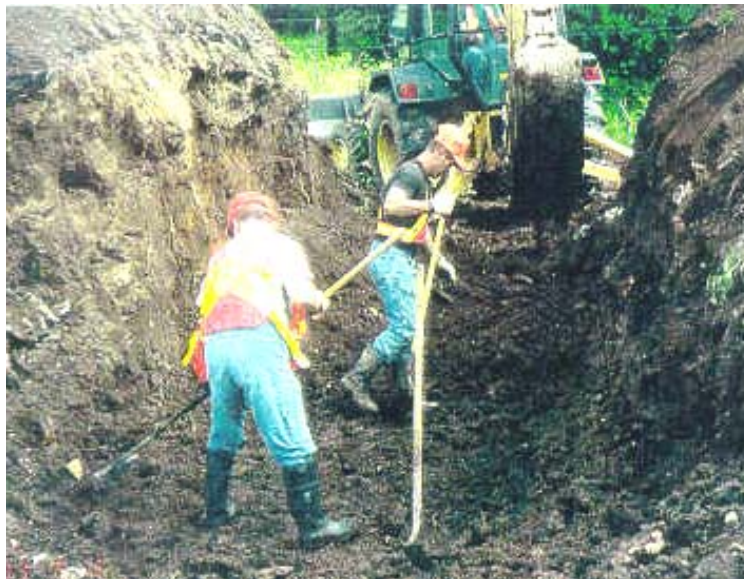
Figure 2. Preparations of Pipe 1 Bedding Foundation

Installation began on the morning of June 17, 1999. The pavement was cut 10 feet wide over the culvert. The existing CMP was removed by 11:00 am and the trench was excavated to the proper width by 12:00 pm. During the excavation of the existing structure and preparation of the trench, a large boulder was removed under the roadway at the upstream end of the culvert and backfill material was worked into the void, however, this may eventually effect the pavement above. The foundation was prepared by raking to grade (see Figure 2). After lunch the crew installed a 4" thick layer of $\frac{3}{4}$ " (-) stone bedding (see Figure 3) which was loosely compacted by hand to the proper grade. The bedding was an AASHTO A-2 material and also met MoDOT bedding materials requirements.

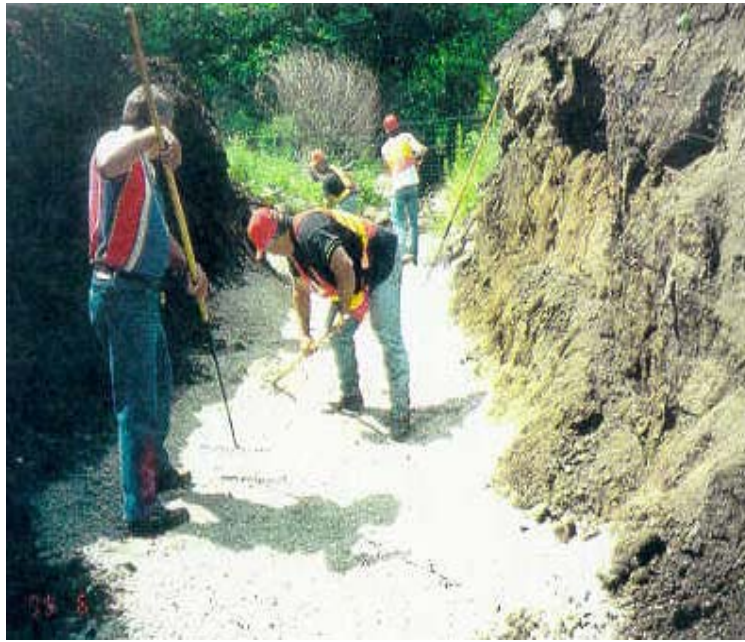
Figure 3. Pipe 1 Bedding Finished to Line and Grade

Pipe 1 had a bedding material of 4" depth, which did not meet MoDOT standard specifications' minimum requirement of 6". In addition, this 4" layer of stone bedding was only loosely compacted by hand, it is highly likely that the bedding did not get enough compaction. In comparison, the bedding materials and compaction procedure for Pipe 2 all met MoDOT standard specifications.

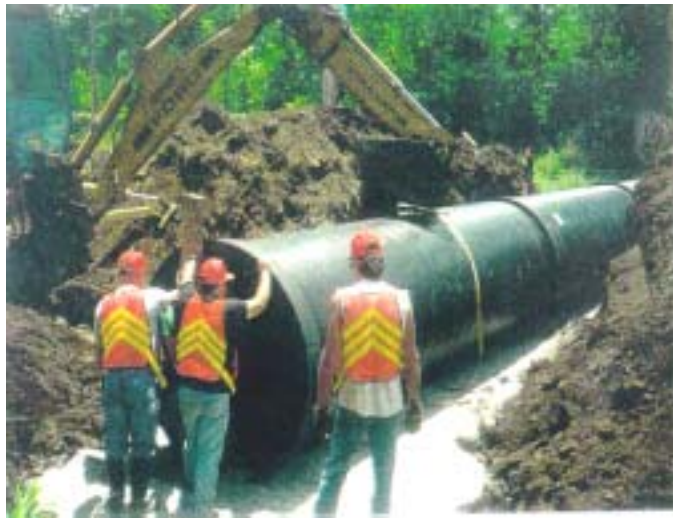
Figure 5. Assembling Pipe 1 Joints

The pipe was laid to grade with bell holes dug at each bell. The joints were assembled by laying the downstream pipe and lowering the upstream pipe with a backhoe, aligning the upstream pipe as it was lowered in place (see Figure 4 and Figure 5). The joints were lubricated prior to installation and pulled together with the backhoe. After all sections of pipe were laid, a chain and come-along were used to pull the joints tight. A visual inspection of the joints showed the maximum opening of any of the joints was approximately 1/2".

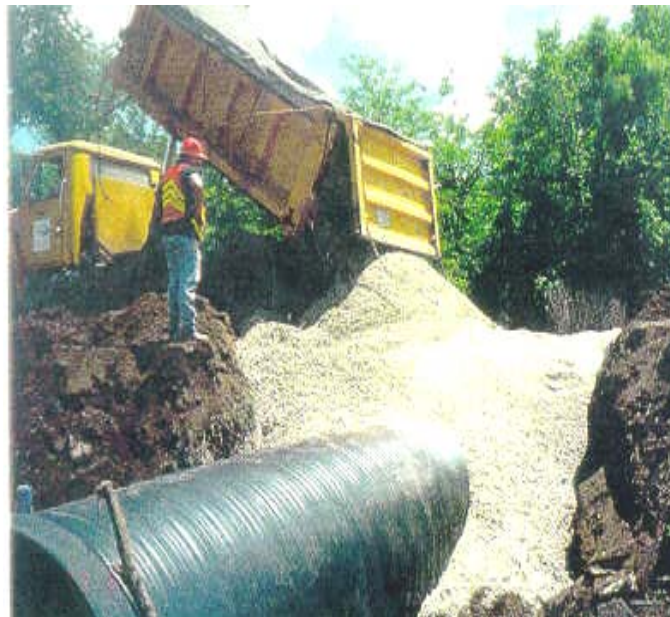
Figure 6. Placing Backfill Above Pipe 1 Midpoint

The pipe beneath the roadway was backfilled with a $\frac{3}{4}$ "(-) crushed stone backfill (AASHTO A-2 material). The first 1-foot lift of backfill was shoveled into place under the haunches; the remaining 6-feet of backfill was then dumped in place in a single lift to the roadway sub-grade (see Figure 6). Outside the roadway, the backfill was native soil (visually a sandy-silt material), which was worked under the haunches and dumped in place over the pipe (see Figure 7). The material was compacted with the backhoe bucket. The pipe was backfilled in accordance with the normal practice of the District 7 Maintenance personnel.

The backfill of Pipe 1 was not compacted at all. In addition, outside the roadway, the backfill used was native sandy-silt soil, while the backfill for the inside roadway part was

¾"(-) crushed stone. This lack of uniformity may have caused the uneven deflection along the pipe, which may further contribute to the joint separations.

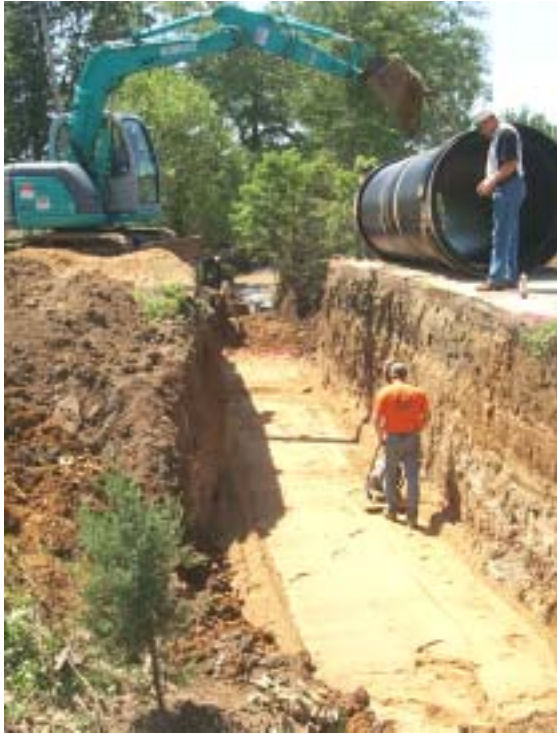
Figure 8. Pipe 2 Bedding Compaction

The two outside 1/3's of the trench bedding was compacted with 4 or 5 passes with the vibratory compactor. The middle 1/3 of the trench was lightly compacted with a single pass of the vibratory plate compactor to provide a cushion for the pipe (see Figure 8). Visual checking indicated a good bedding compaction.

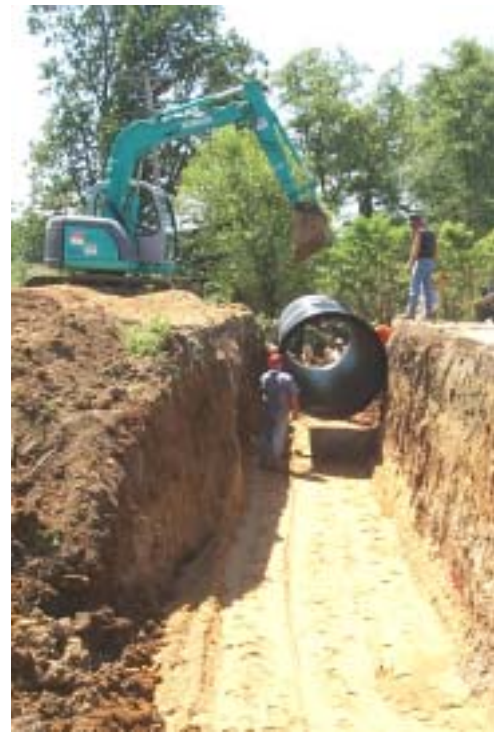
Figure 9. Narrow Trench of Pipe 2

When the pipe was laid into the trench at approximately 1:45 p.m., however, the trench width was found out to be narrower than the minimum specified (see Figure 9). Due to urgency in getting the pipe installed and the roadway back open by 3:00 p.m., there was no time to widen the trench.

When Pipe 2 was installed, the trench width did not meet the required minimum of 96", the actual width was around 84". The narrower trench made it impossible to mechanically compact the haunch materials.

If there are other large size HDPE pipes to be installed in Missouri, strict installation procedure should be followed.

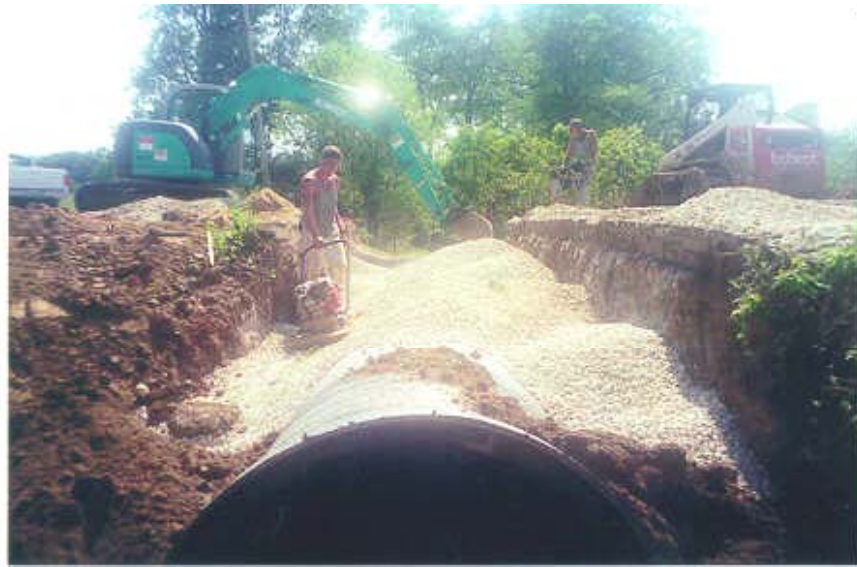
Figure 10. Pipe 2 Backfill Compaction Above Pipe Midpoint

Due to the narrow trench, and trying to get the pipe installed and the roadway open to traffic, Krupp decided not to mechanically compact the 1" clean stones until the backfill was at, or above the midpoint of the pipe. The checking by ADS representative indicated that the backfill was likely being compacted in the haunch zone. The backfill above the pipe midpoint was compacted with the vibratory compactor (see Figure 10).

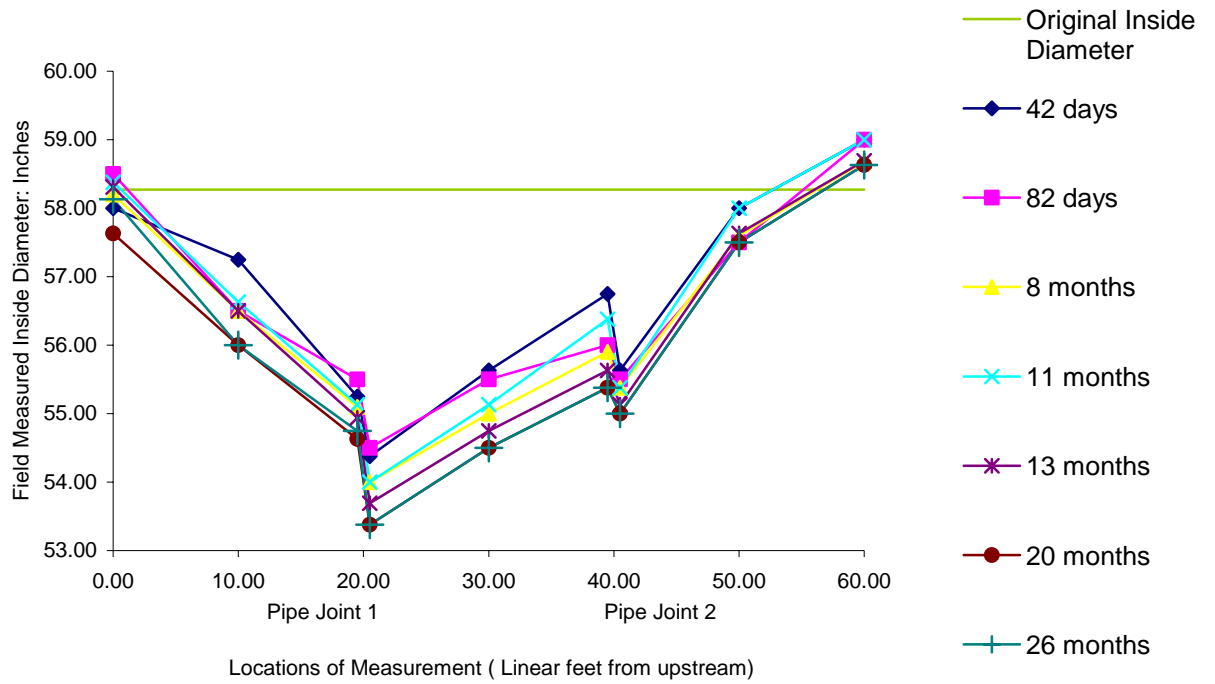
Figure 11. Pipe 1 Vertical Deflection

The pipe had a maximum deflection of 4.6% shortly after installation. Most of the deflection was probably due to the low compaction effort of the installation, however, the deflection has been steadily increasing as shown in Table 2 through Table 9 (the numbers in red indicate maximum deflection), and Figure 11 and Figure 12.

Judging from these tables and figures, it is apparent that the actual deflection has changed only in minimal increments since the installation of the pipe. Ever since the installation, the point of maximum deflection has been located at upstream part of section 2. After 42 days of installation, its vertical deflection was 6.7%, horizontal deflection was 7.3%. Thirteen months after, vertical deflection increased to 7.9% and horizontal deflection increased to 8.3%. After around 26 months, the vertical deflection is 8.4% and horizontal deflection stays as 8.3%.

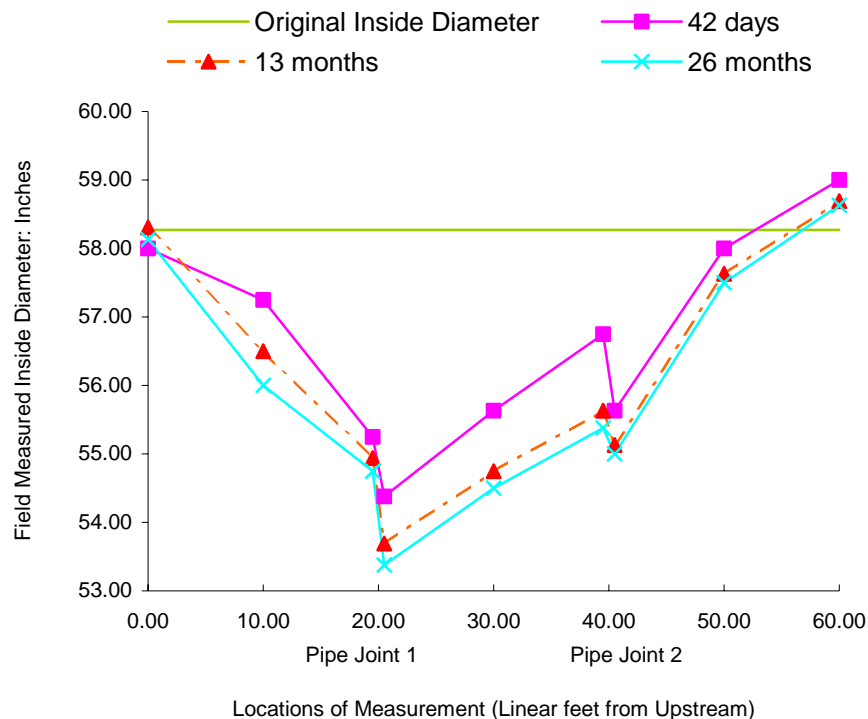
Figure 13. Pipe 1 Vertical Deflection at Three Time Points

Most of the deflection occurred during the first 42 days after the installation. Comparing the deflections at 42-days, 13-months and 26-months after installation (see Figure 13 and Figure 14), it is obvious that the deflection has been slowing down, or has stabilized.

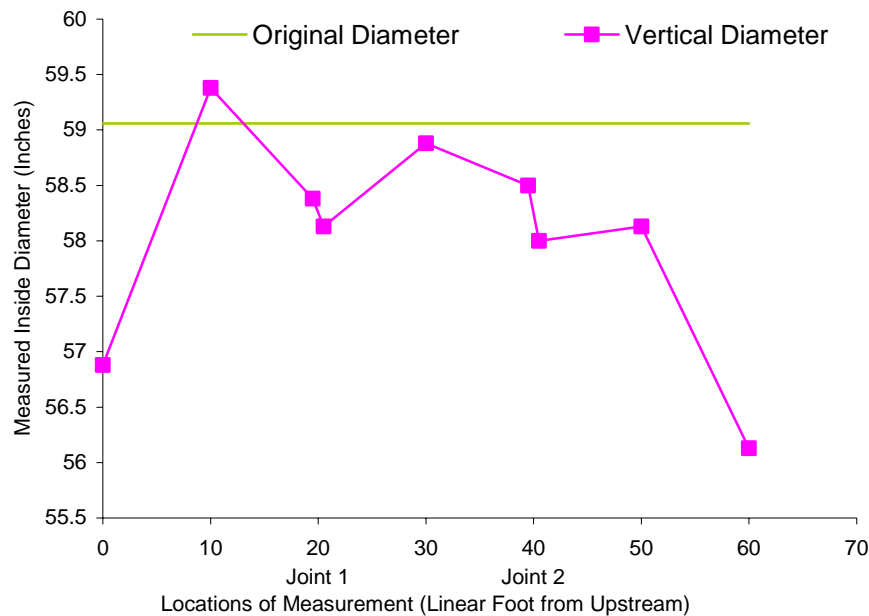
Figure 15. Pipe 2 Vertical Deflections

Pipe 2 did not have a fully qualified installation, but it is performing well. The two-week-after-installation deflection was rather small. One year after installation, the maximum deflection was 5% and the deflection at this point was much higher than other points where deflections were measured. Though the joint separations were wider than expected, considering the overlapping joint is around 9.57" wide, and the deflections across the joint upstream and downstream points are rather even, there may be no threat of leaking. Long-term undermining is not known at this time. So far, it seems no major maintenance work is expected within the next few years.
